# Using Remote Detection Technology to Monitor Endangered Fish in the San Juan River

Christopher Cheek  
Navajo Nation  
Department of Fish and Wildlife

# PIT Tag Technology in SJR

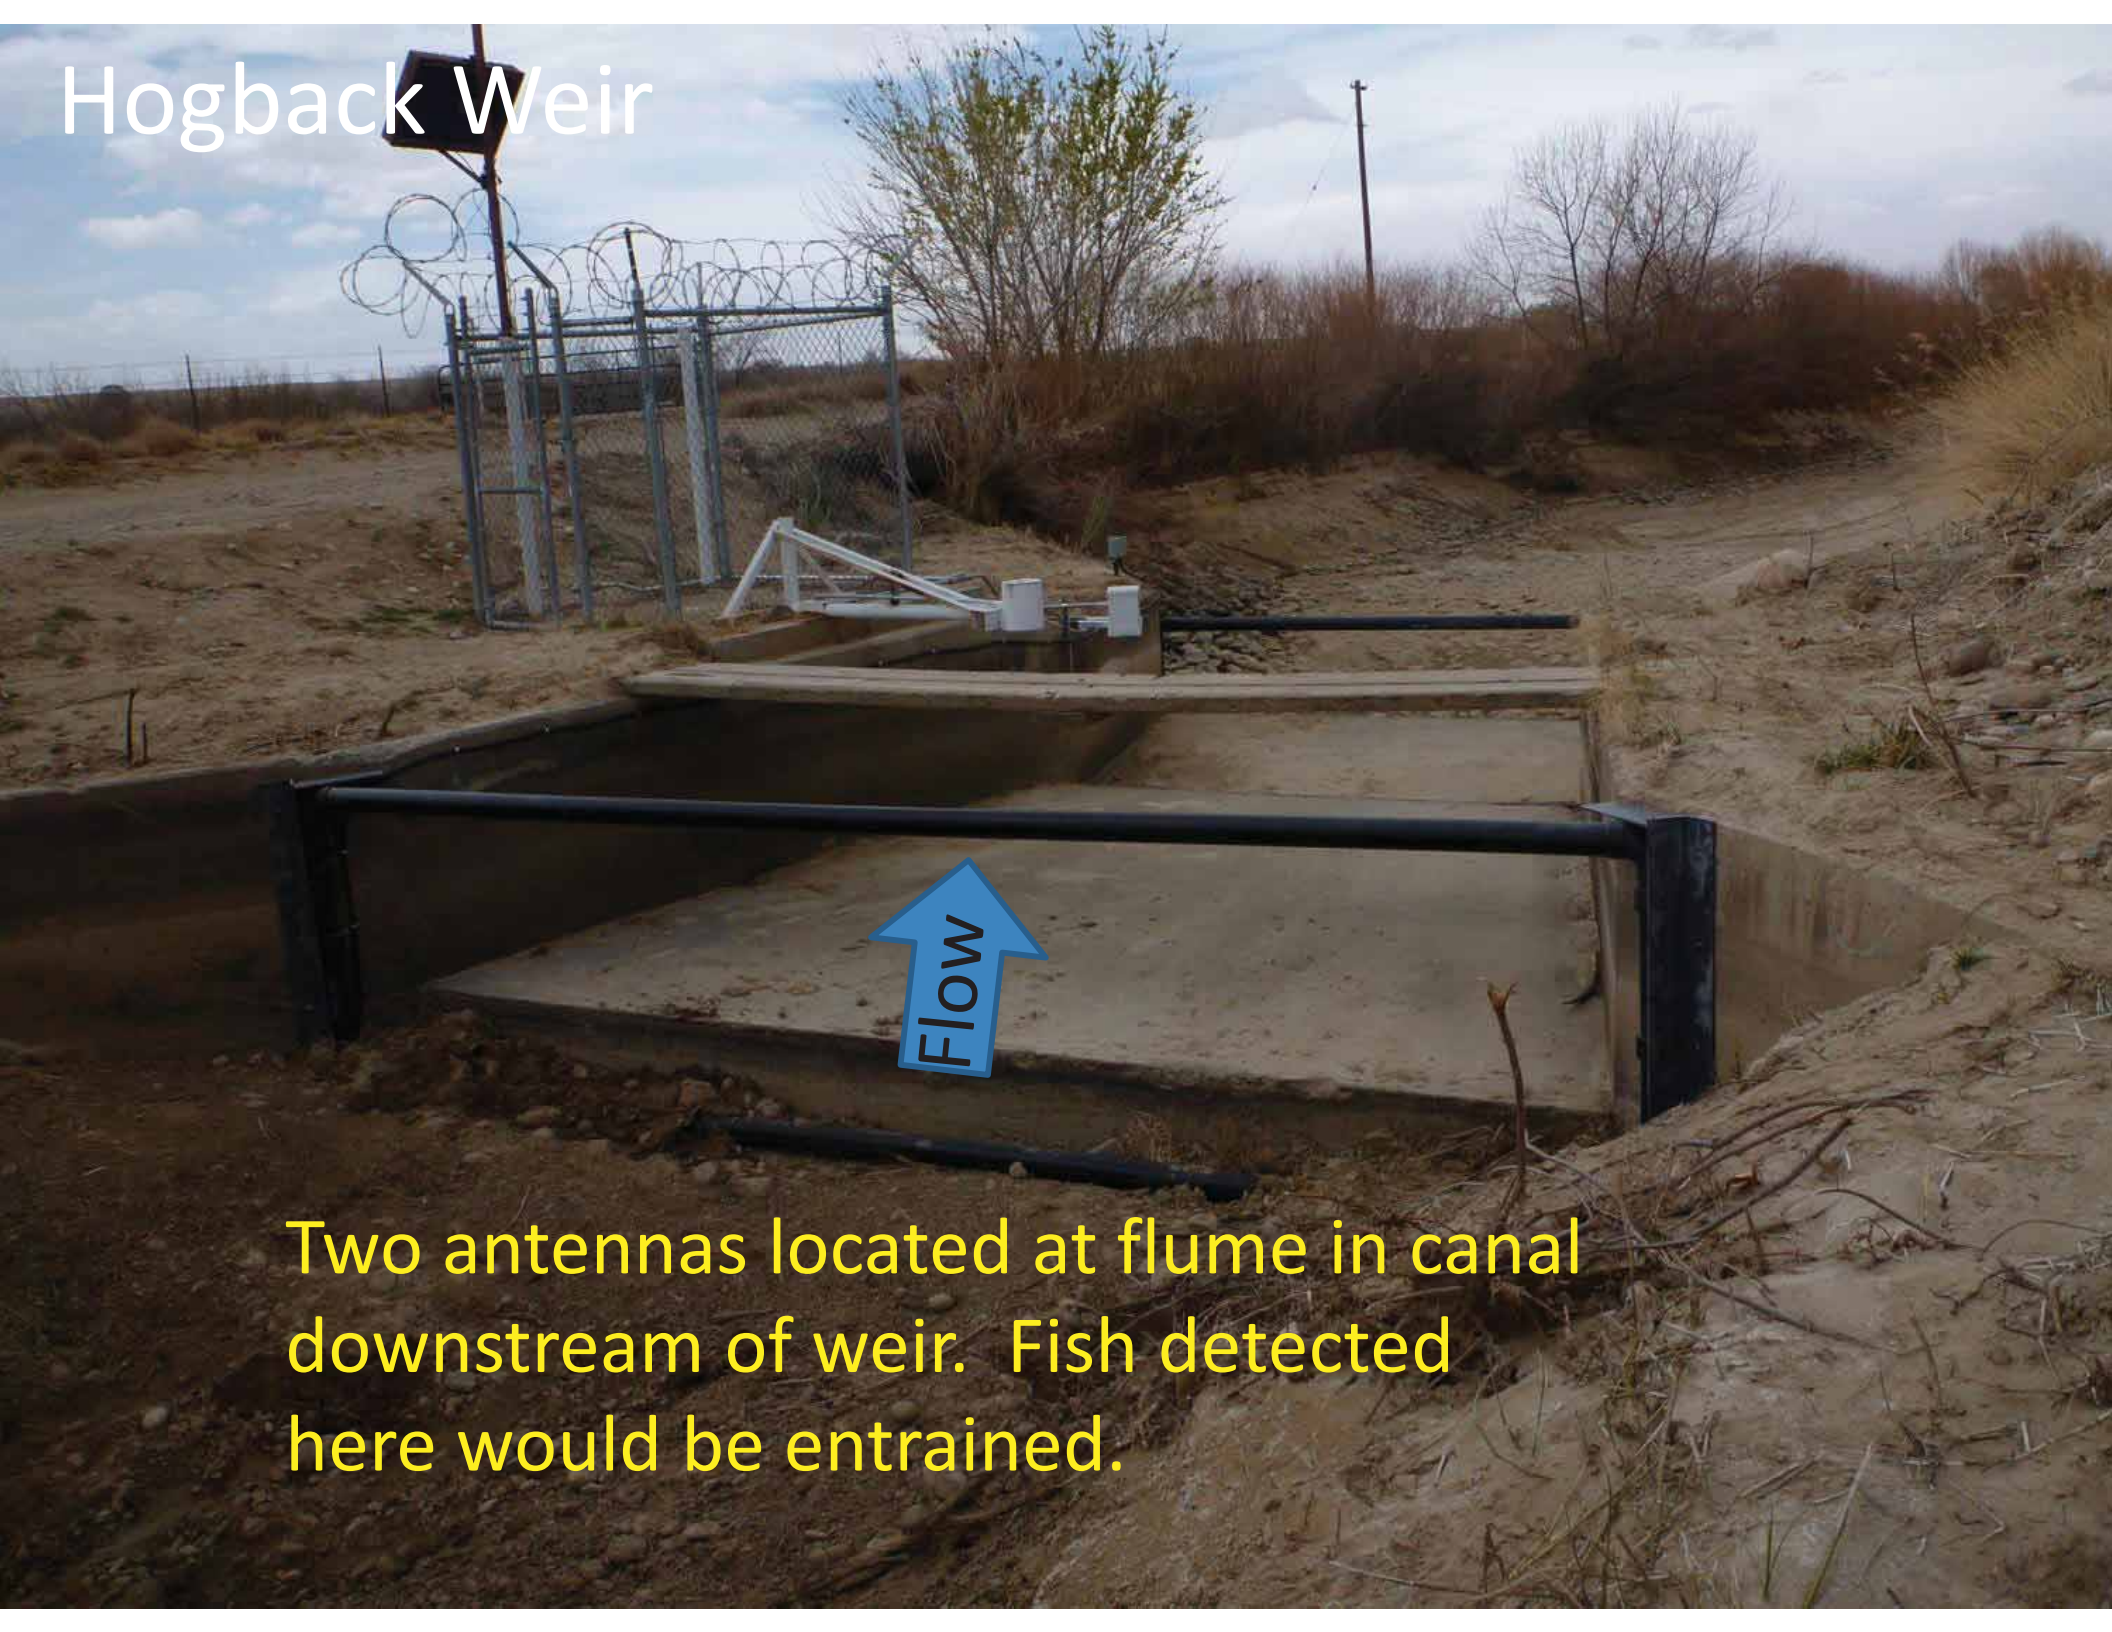
# Hogback Weir

Two antennas located at flume in canal downstream of weir. Fish detected here would be entrained.

- Installing Antennas is not as simple as it sounds
- Everywhere we put antennas we get detections!
  - 700+ Unique Fish Detected in 2014
  - Data can be overwhelming
- PNM Fish Passage is ineffective
  - Updates to improve efficiency in 2015
  - BIA funded purchase of self cleaning screens
  - Test effectiveness after updates in 2015
- Hogback Fish Diversion was successful in limiting entrainment of endangered fish
  - 3% entrainment in experiment with stocked fish

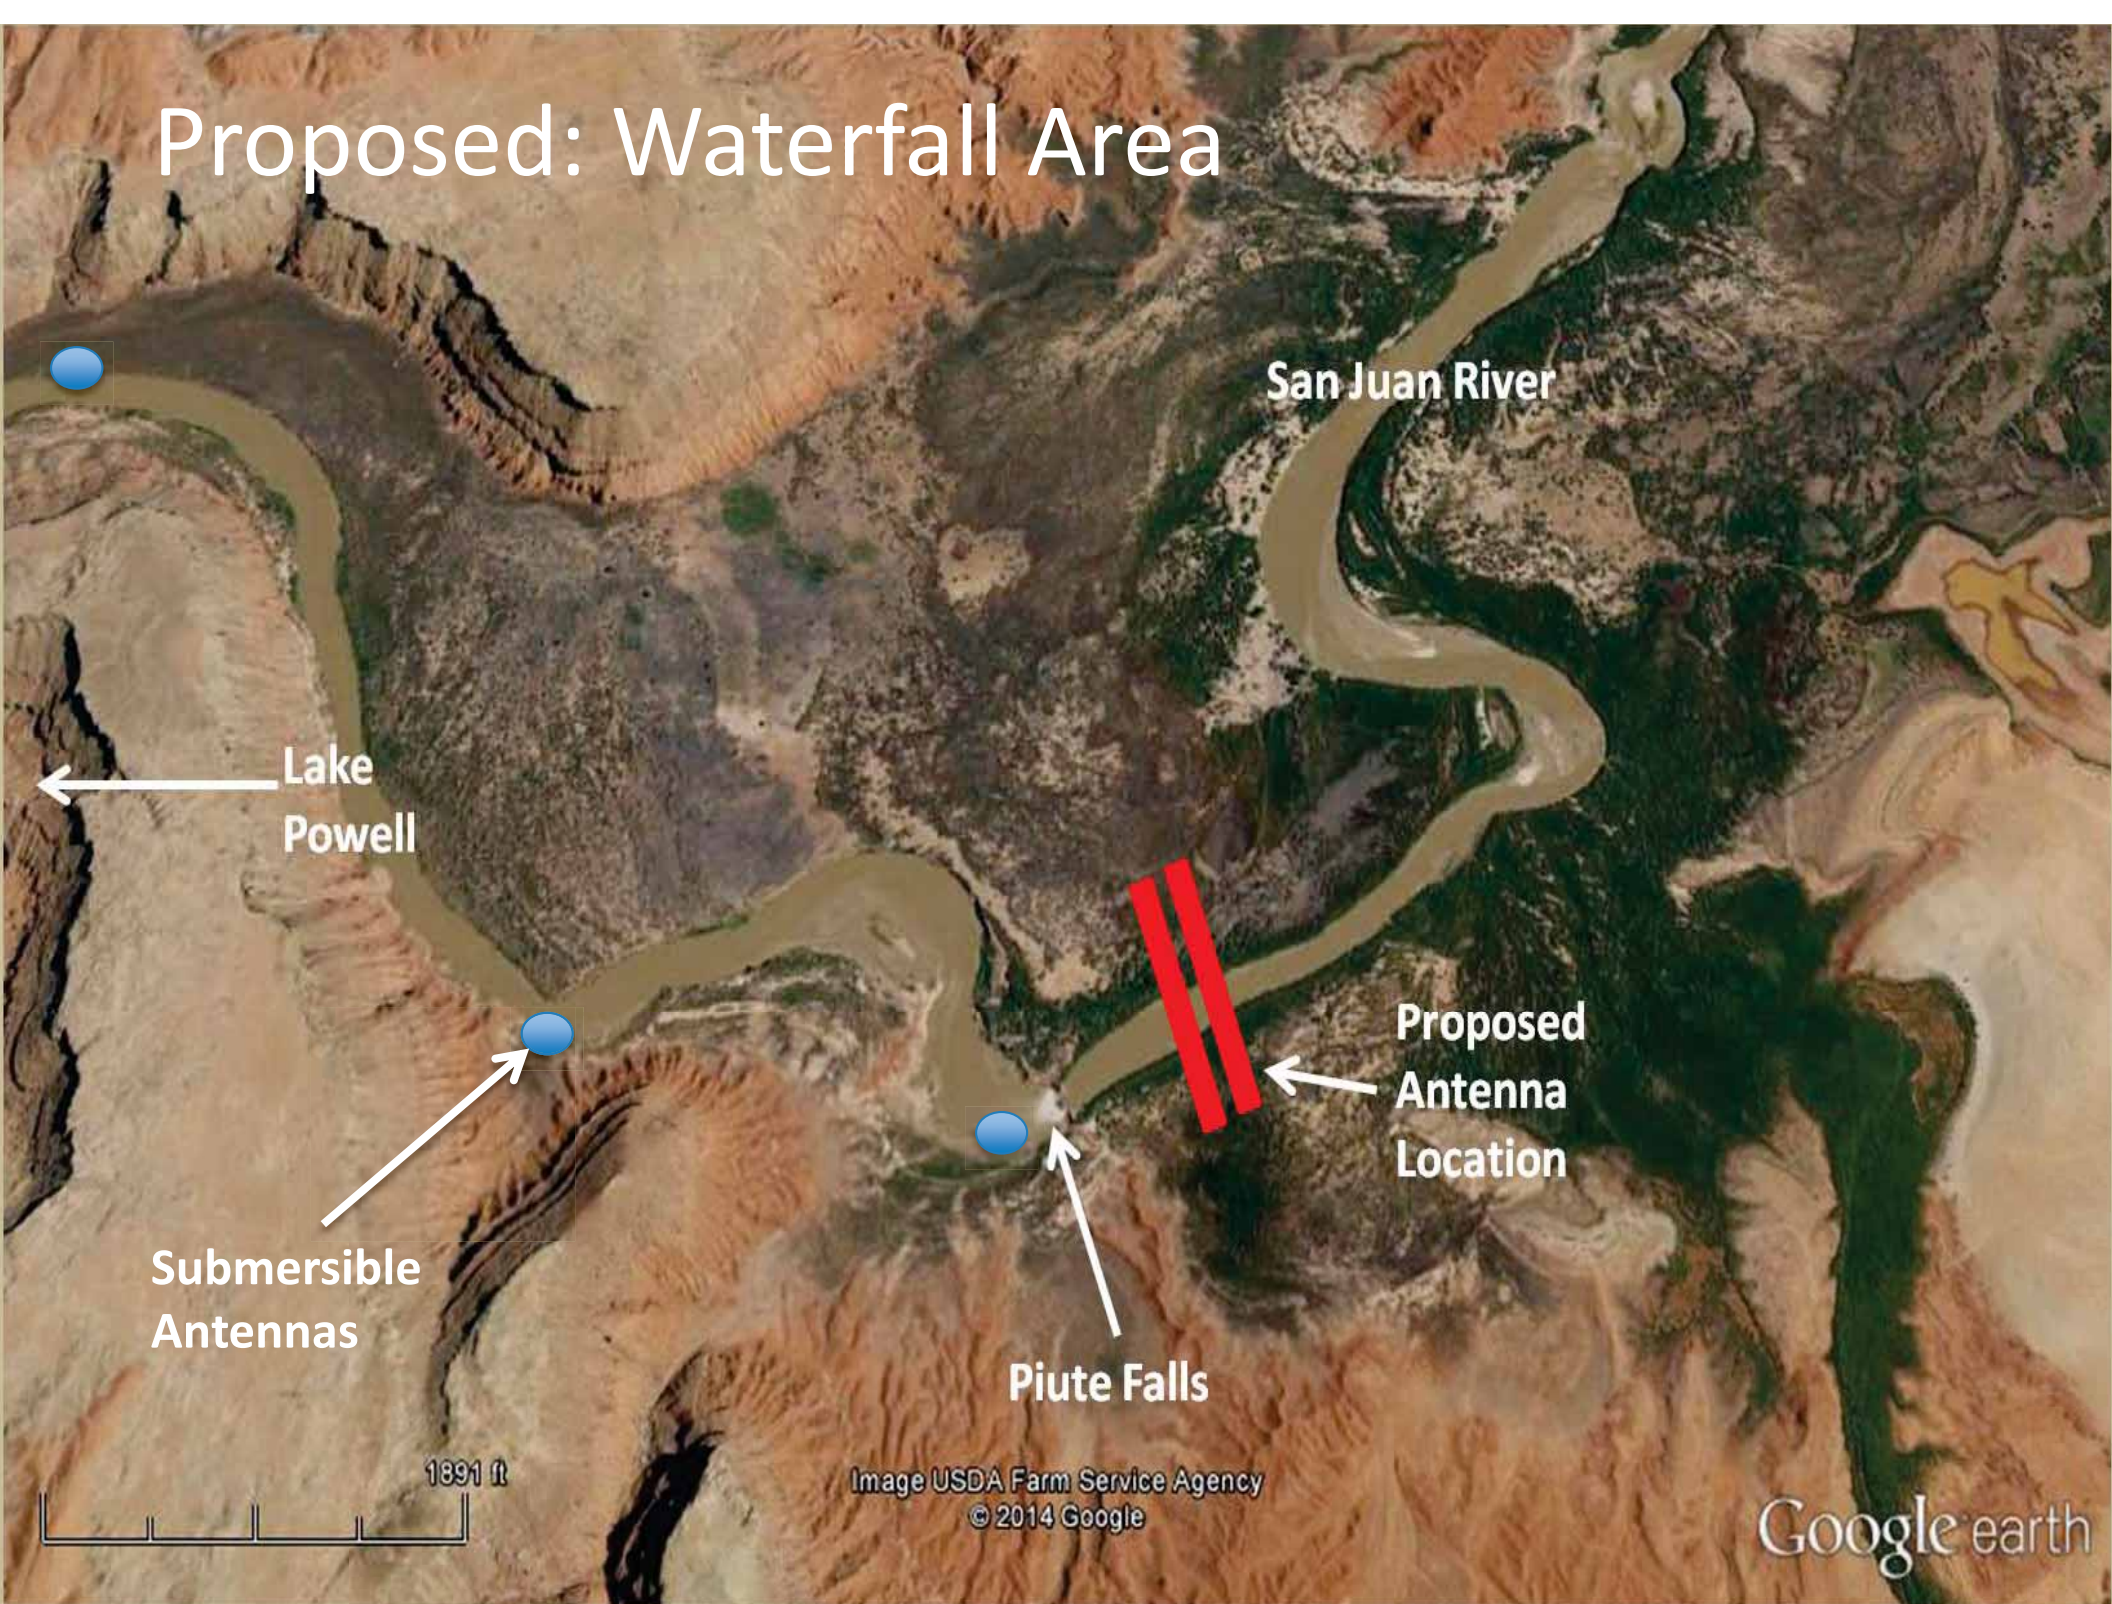
# Proposed: Waterfall Area

- Proposed Antenna Objectives:
  - Evaluate endangered fish use of the Animas River
  - Determine loss of endangered fish into Lake Powell
  - Investigate timing of Razorback Sucker movement downstream of Piute Falls
